"Georgian Water and Power"

MARNEULI DIRRECTION PUMPING AREA

ASSESSING HEALTH AND SAFETY CONDITIONS IN FACILITIES AND WORK AREAS AND PLANNING IMPROVEMENT MEASURES

16.09.2025

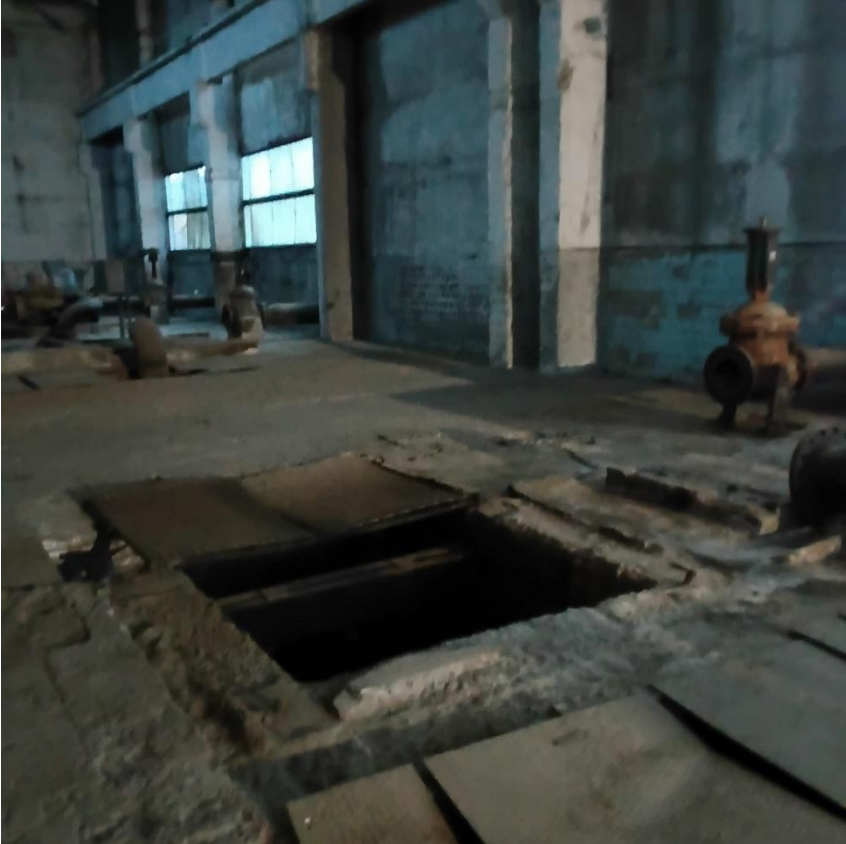
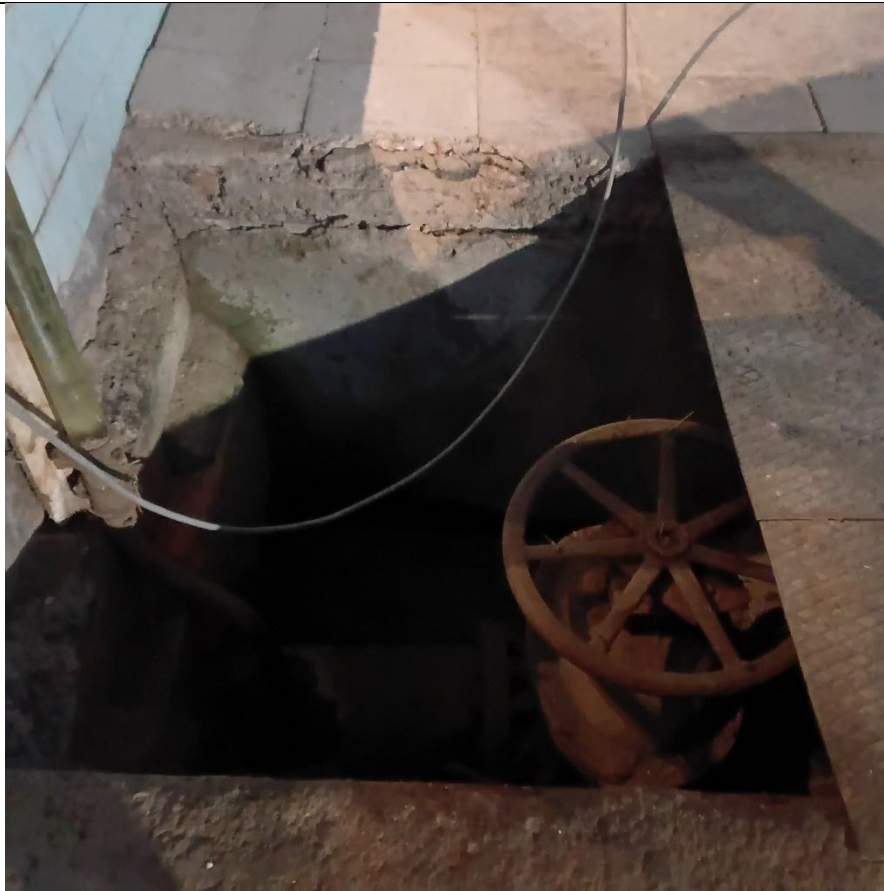
<p>Finding: The floor in the pump room is uneven, with multiple openings that could cause an employee or other person to trip, fall into the opening, and sustain injuries.</p> <p>The infrastructure is completely inappropriate for the work space</p>

<p>The floor of the working space must not be slippery, have a dangerous uneven surface, and must be solid, without holes, slopes and protrusions.</p> <p>(Government of Georgia Resolution No. 341 July 1, 2022. Article 5. P.2.)</p> <p>Openings (wells, pits, stairwells, any place where a person may fall) must be covered with special covers and/or sheets.</p>
--------------------------------------------------------------------------------------------------------------------------------------------------------------------------------------------------------------------------------------------------------------	-------------------------------------------------------------------------------------	-------------------------------------------------------------------------------------------------------------------------------------------------------------------------------------------------------------------------------------------------------------------------------------------------------------------------------------------------------------------------------------

Resolution #477
October 27, 2017,
Article 15

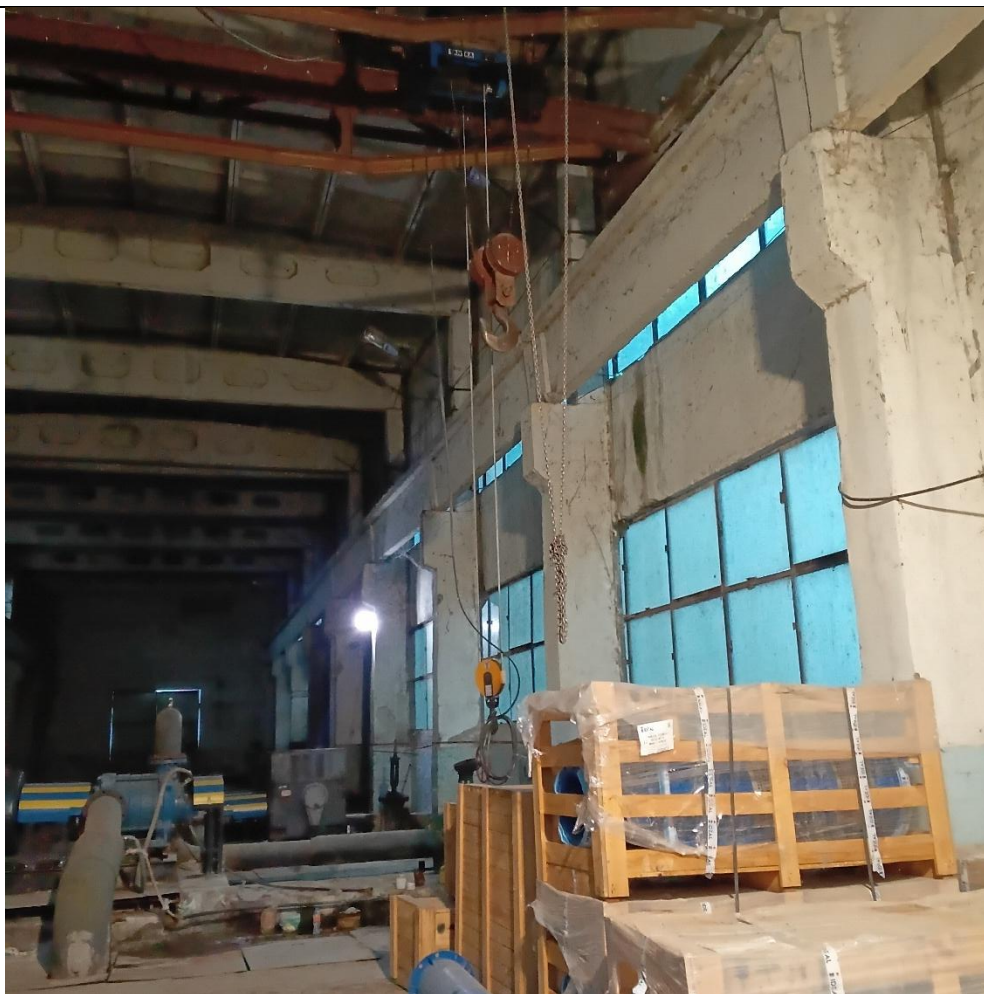
The windows of the pump house have broken glass, which, if they fall, could cause physical injury to the employee and another person; it could also cause a malfunction of the climate control.

Restore damaged windows

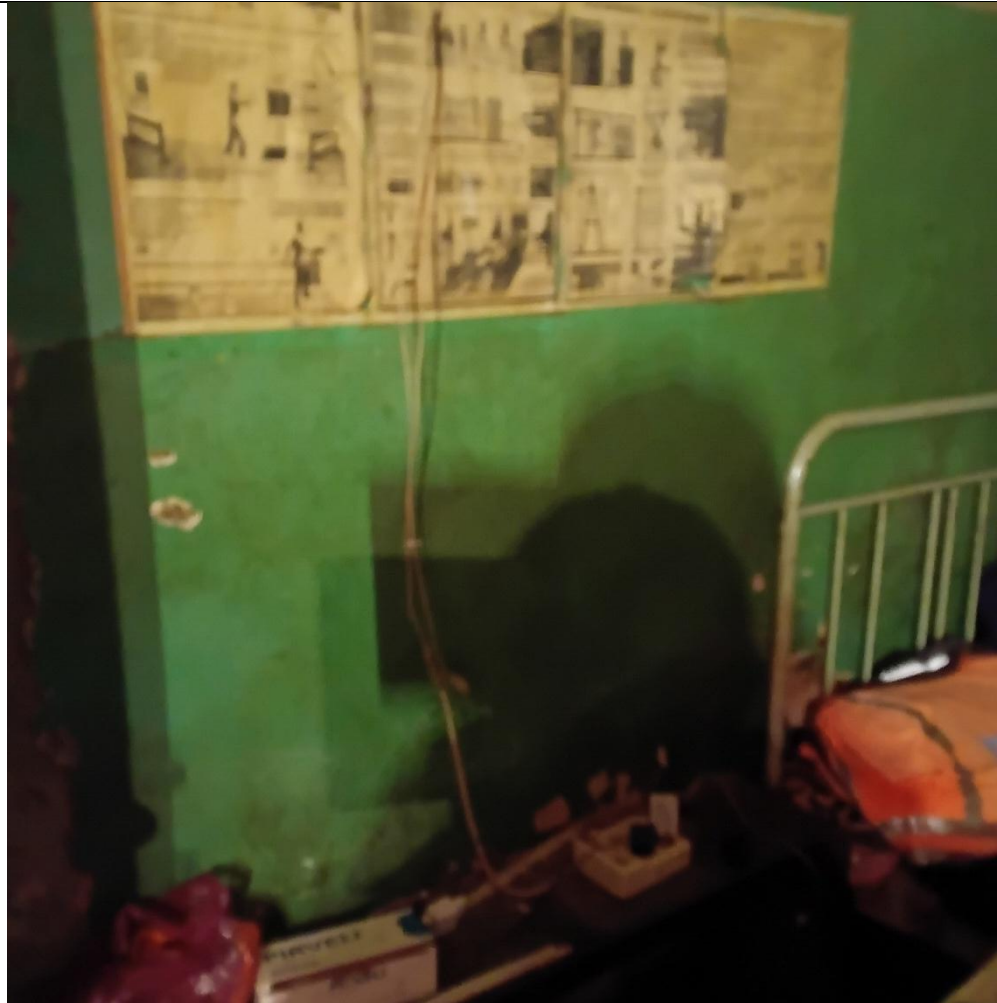
Electrical equipment and wiring are not up to standard, there are exposed wires, they are not installed in cable channels, which can cause a fire. Voltage transfer

Electrical equipment and wiring must be designed and installed in compliance with the relevant regulatory norms so that the working space is adequately protected from fire and explosion hazards.

(Resolution of the Government of Georgia No. 341 July 1, 2022. Article 3. P.1.

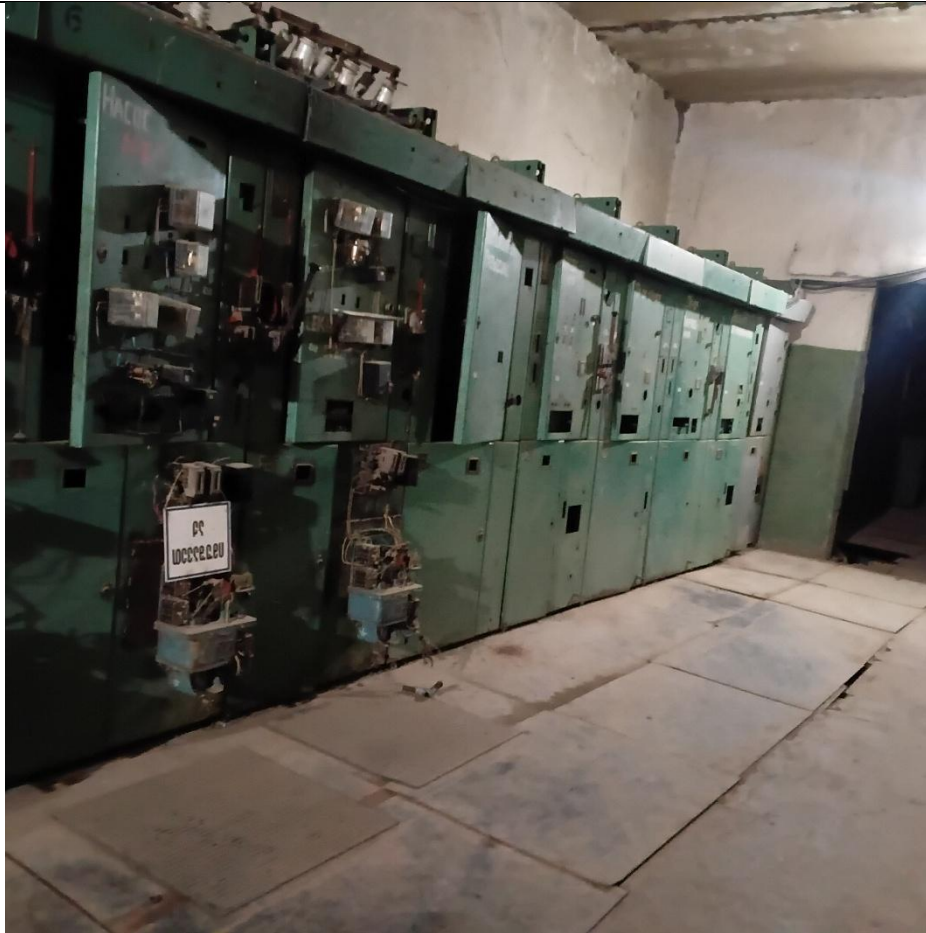
Discovery: The electrical utility point (high voltage) is in a completely unprotected area, there is no separate room, it is not fenced and locked. Virtually all visitors can get close to the cabinets.

There are no warning signs and the doors are open

Arrange according to the standard, no other person is allowed in the territory except the authorized person.

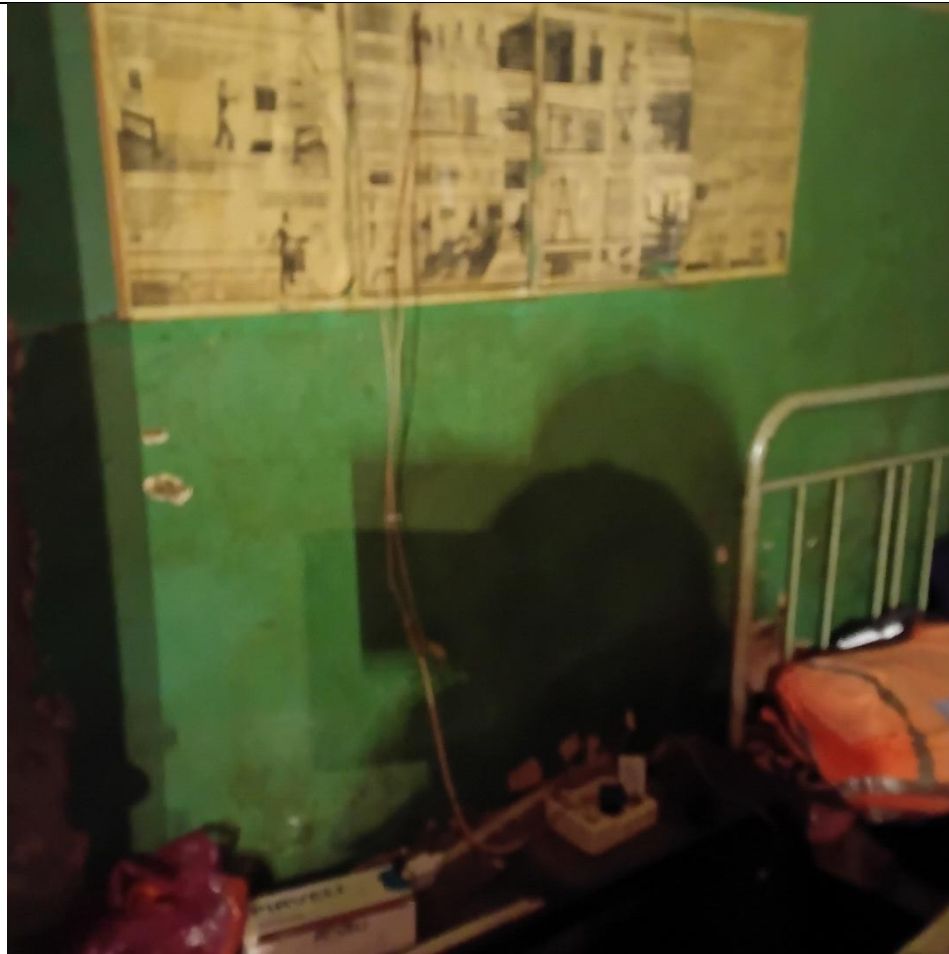
The employee's workspace is inappropriate in terms of ergonomics.

The employee's space should be furnished according to the standard, it needs renovation.

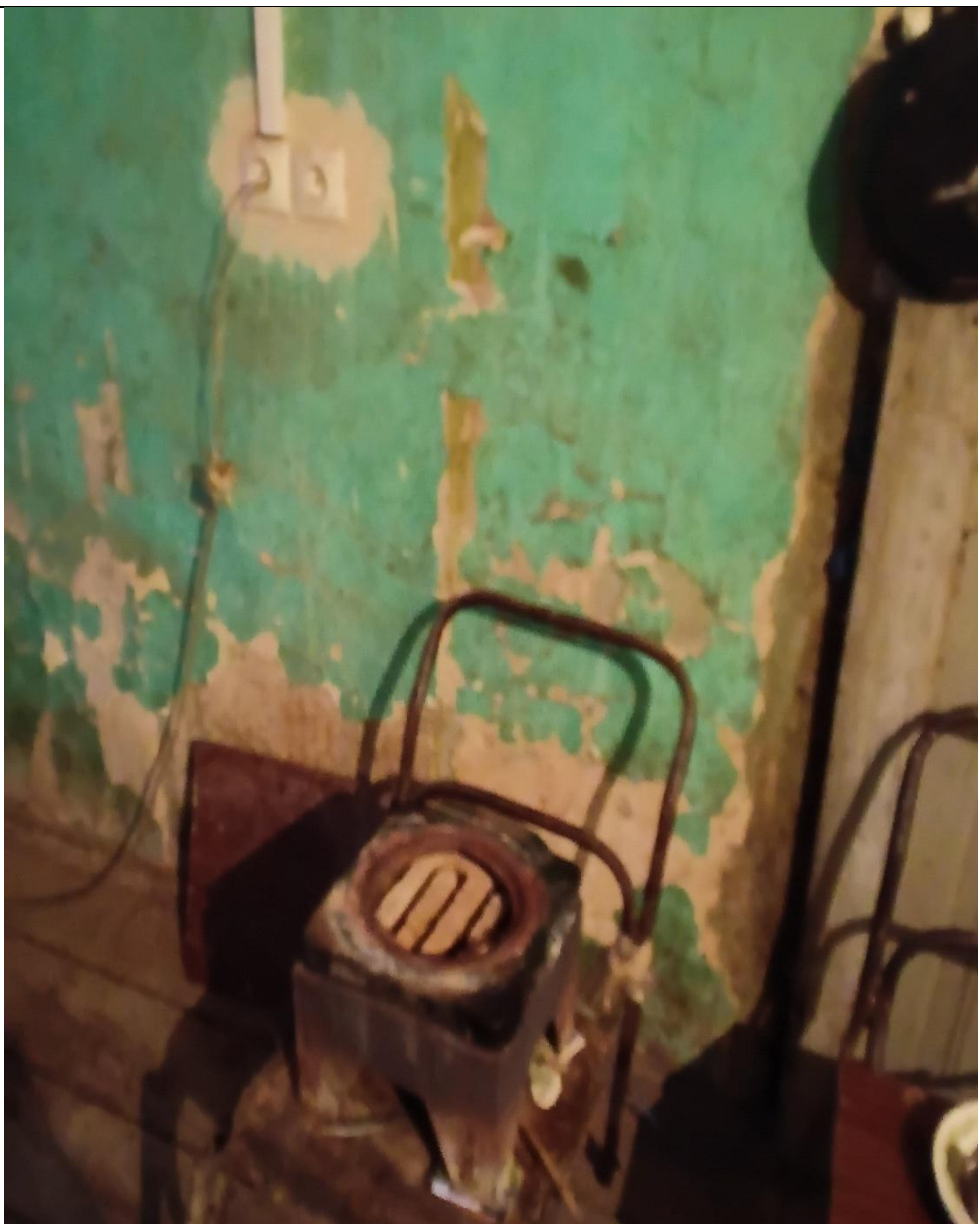
They will use a prohibited heater for household needs.

A dining area with a bathroom and appropriate safety equipment should be provided.

The heater in question should be removed from service immediately.

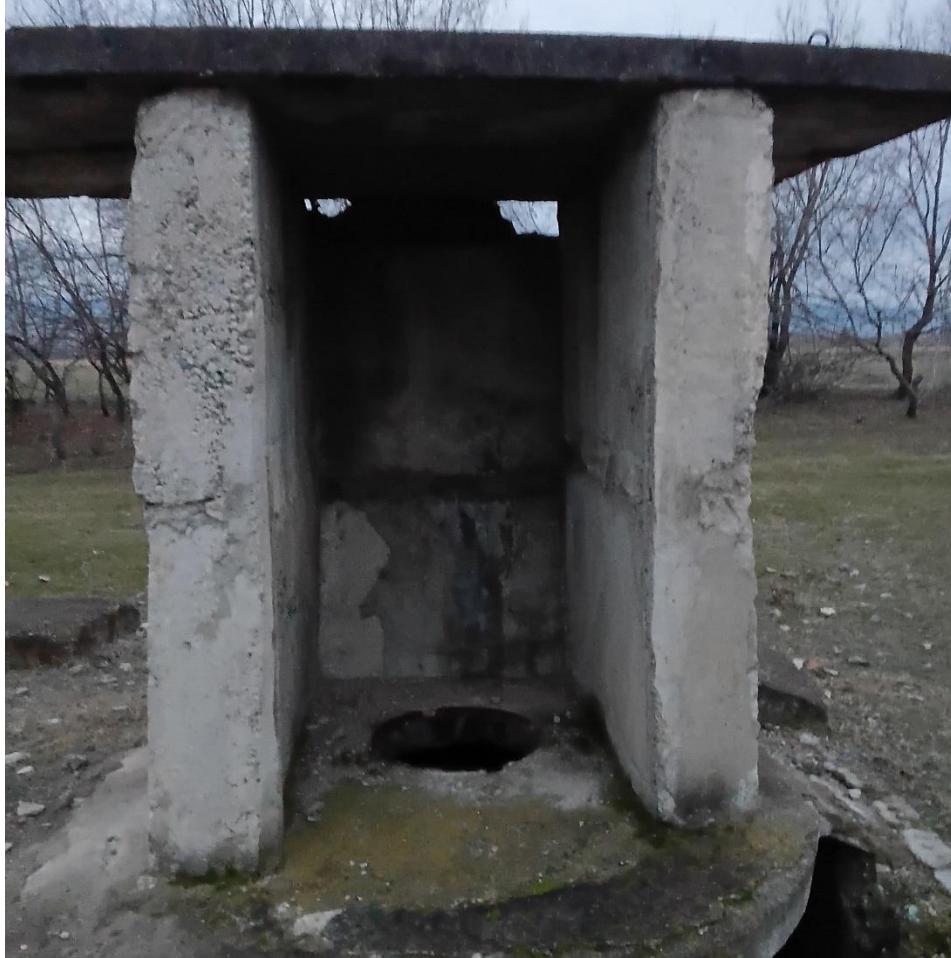
There are no toilets in/near the Satumbo area.

1. The required number of toilets must be located near the workplace, rest and changing rooms, showers, and washbasins.
2. Toilets must be equipped with an exhaust fan or ventilation system and washbasins.

(Resolution of the Government of Georgia No. 341 of July 1, 2022. Article 18. P.1; P.4.
