"Georgian Water and Power"

MARNEULI DIRRECTION PUMPING AREA

ASSESSING HEALTH AND SAFETY CONDITIONS IN FACILITIES AND WORK AREAS AND PLANNING IMPROVEMENT MEASURES

16.09.2025

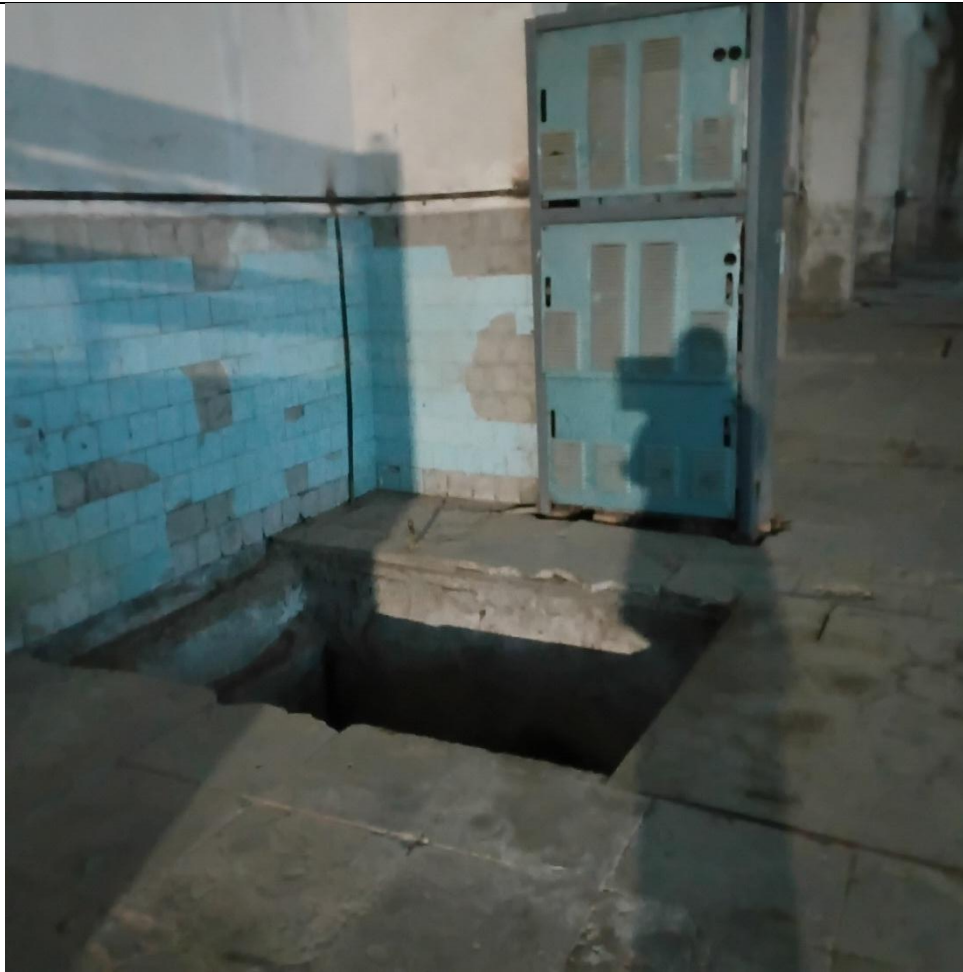
<p>Finding: The floor in the pump room is uneven, with multiple openings that could cause an employee or other person to trip, fall into the opening, and sustain injuries.</p> <p>The infrastructure is completely inappropriate for the work space</p>

<p>The floor of the working space must not be slippery, have a dangerous uneven surface, and must be solid, without holes, slopes and protrusions.</p> <p>(Government of Georgia Resolution No. 341 July 1, 2022. Article 5. P.2.)</p> <p>Openings (wells, pits, stairwells, any place where a person may fall) must be covered with special covers and/or sheets.</p>
--------------------------------------------------------------------------------------------------------------------------------------------------------------------------------------------------------------------------------------------------------------	-------------------------------------------------------------------------------------	-------------------------------------------------------------------------------------------------------------------------------------------------------------------------------------------------------------------------------------------------------------------------------------------------------------------------------------------------------------------------------------

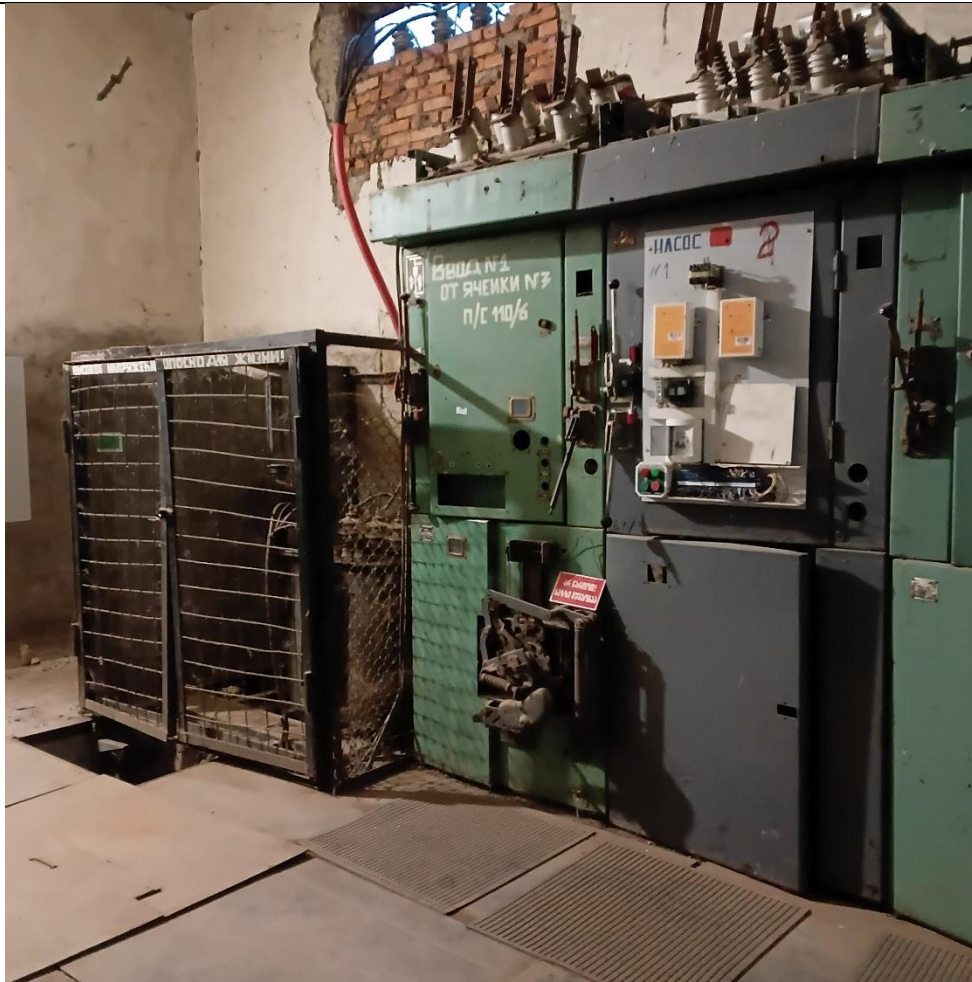
Discovery: The electrical utility point (high voltage) is in a completely unprotected area, there is no separate room, it is not fenced and locked. Virtually all visitors can get close to the cabinets.

There are no warning signs and the doors are open

Arrange according to the standard, no other person is allowed in the territory except the authorized person.

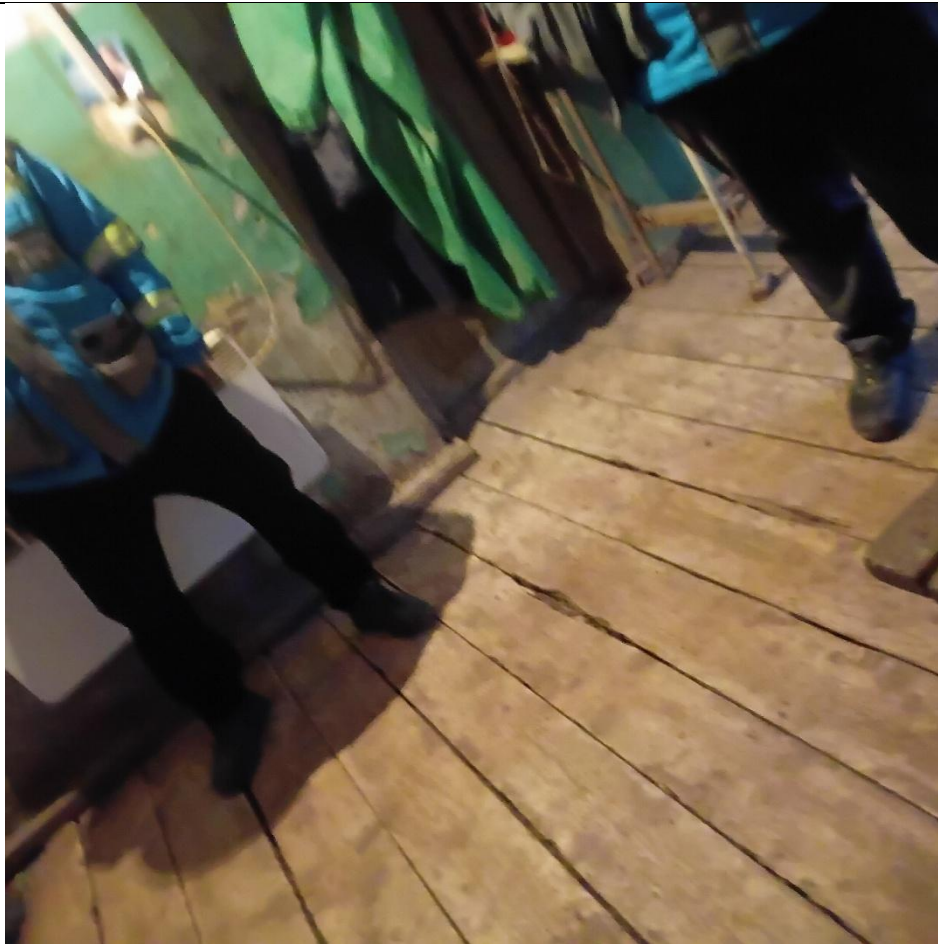
The employee's workspace is inappropriate in terms of ergonomics.

The employee's space should be furnished according to the standard, it needs renovation.
